Above the Flood: Elevating Your Floodprone House

FEMA 347/ May 2000

Hurricane Andrew damaged hundreds of homes in south Florida.

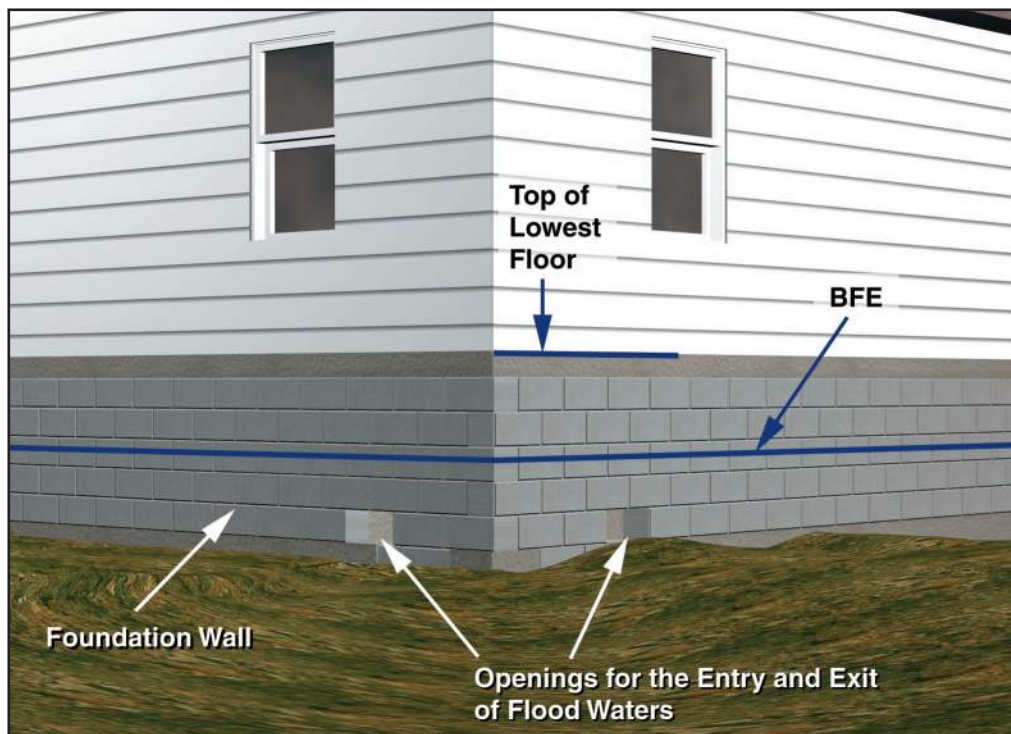
**Figure 6**

In a new, substantially improved, or substantially damaged building in an A zone, the elevation of the lowest floor must be at or above the BFE.

In A zones, where flood hazards are less severe, buildings may be elevated either on an open foundation or on continuous foundation walls below the BFE (Figure 6). Regardless of the type of foundation used, A-zone buildings must be elevated so that the **lowest floor** is at or above the BFE, as shown in Figure 6. If continuous walls are used below the BFE, they must be equipped with openings that allow flood waters to flow into and out of the area enclosed by the walls (Figure 6). Allowing the entry and exit of flood waters ensures that water pressures will be the same on both sides of the walls and reduces the likelihood that water pressure will cause the walls to fail.

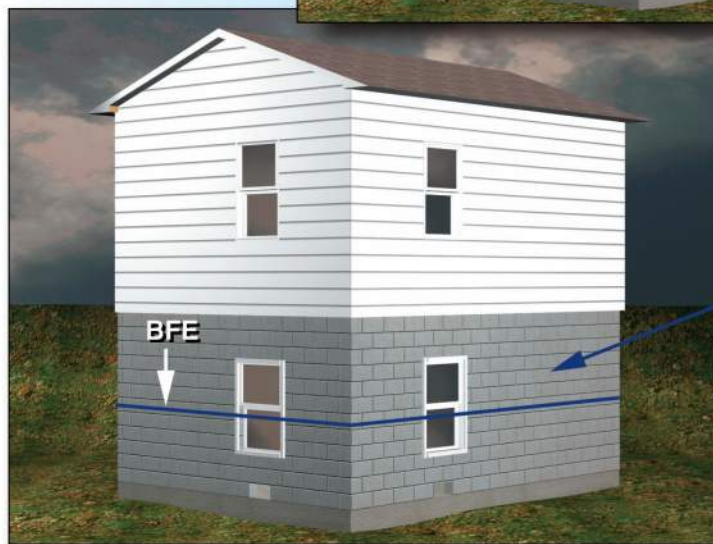
Technique 2 – Convert the existing lower area of the house to non-habitable space and build a new second story for living space.

House at the time Hurricane Andrew struck

New Second Story Above BFE

Substantially damaged house undergoing repairs that will bring it into compliance with Miami-Dade County floodplain management requirements

House after completion of repairs

Lower Area Converted to Non-Habitable Space for Storage, Parking, or Building Access

1. Extend the walls of the house upward and raise the lowest floor (Figure 7).
2. Convert the existing lower area of the house to non-habitable space and build a new second story for living space (Figure 8).
3. Lift the entire house, with the floor slab attached, and build a new foundation to elevate the house (Figure 9).

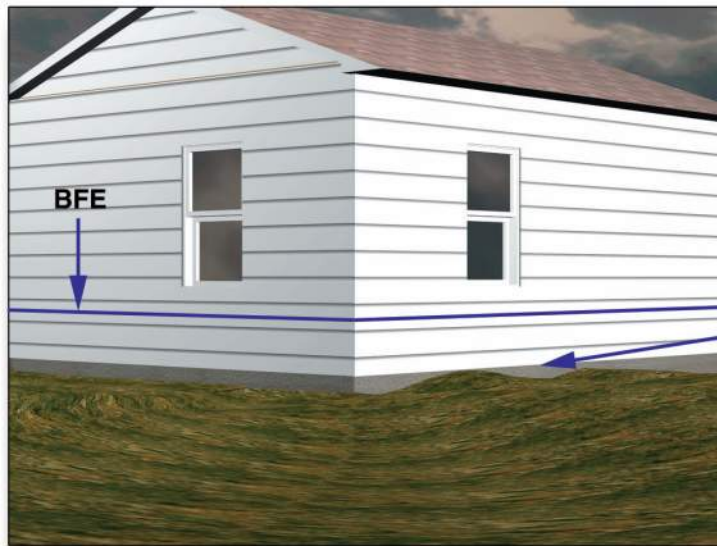
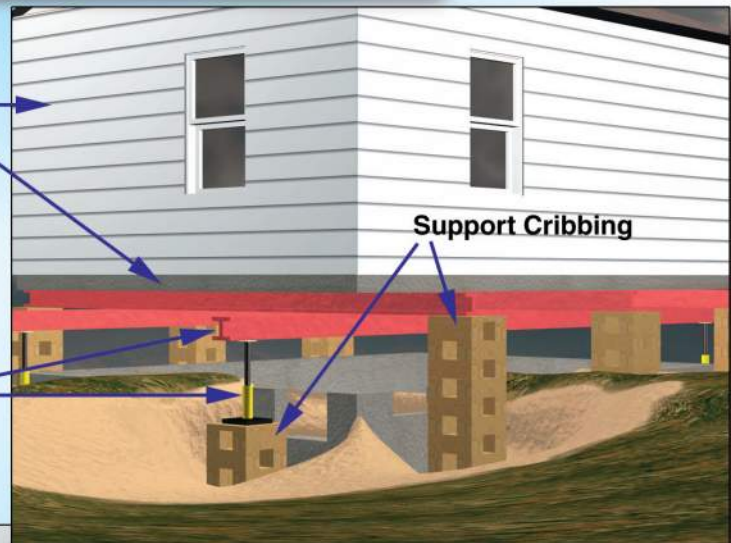
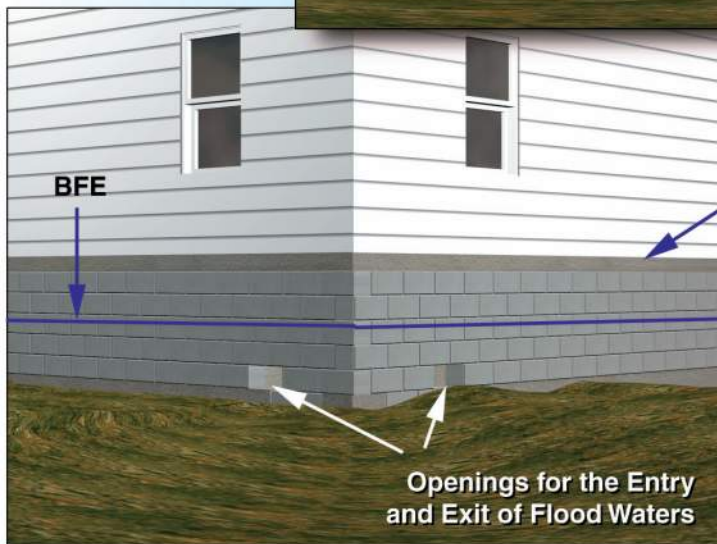
Figure 9
Technique 3 –
Lift the entire house,
with the floor slab
attached, and build
a new foundation to
elevate the house.

House at the time
Hurricane Andrew
struck

Original Level
of the Lowest
Floor

House and
Floor Slab
Lifted
Together

House Lifted
on Jacks and
I-Beams

Support Cribbing

New Level
of the Raised
Lowest Floor

House after
completion of
repairs

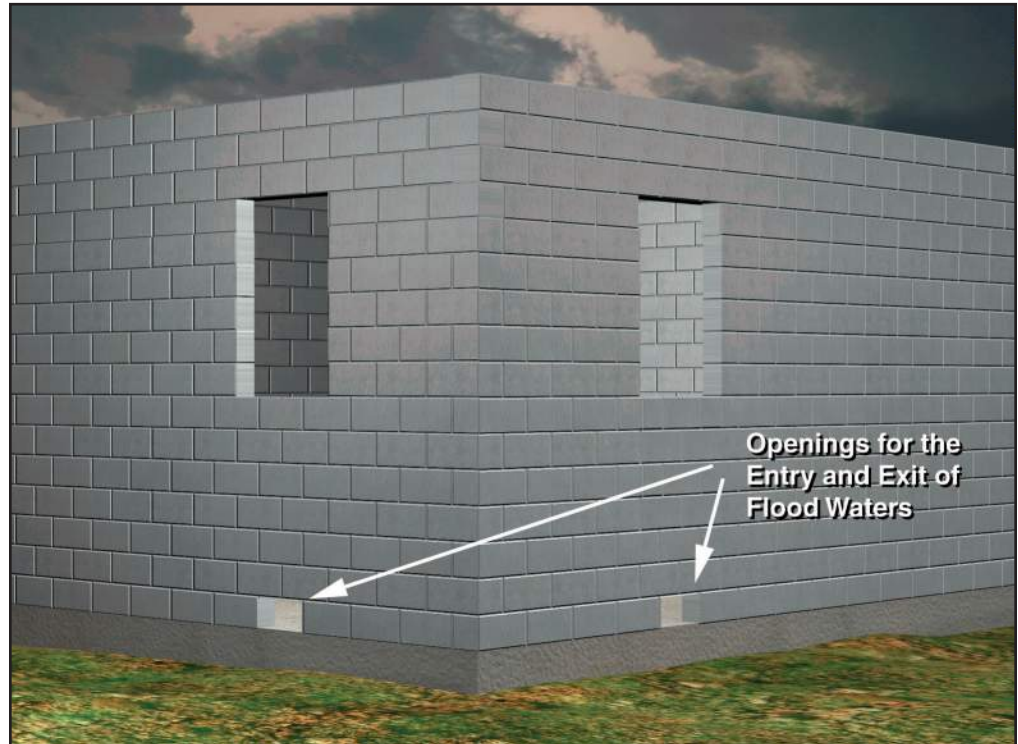
Figure 12
Openings are created in the walls near the ground.

Blocks are removed from the walls of the house at selected locations within 1 foot of the ground (Figure 12). The resulting openings will allow flood waters to flow into and out of the lower area of the house so that the water pressures on both sides of the walls will remain the same. The roof and windows are then replaced, and a new wood-frame floor is constructed above the flood level (Figure 13).

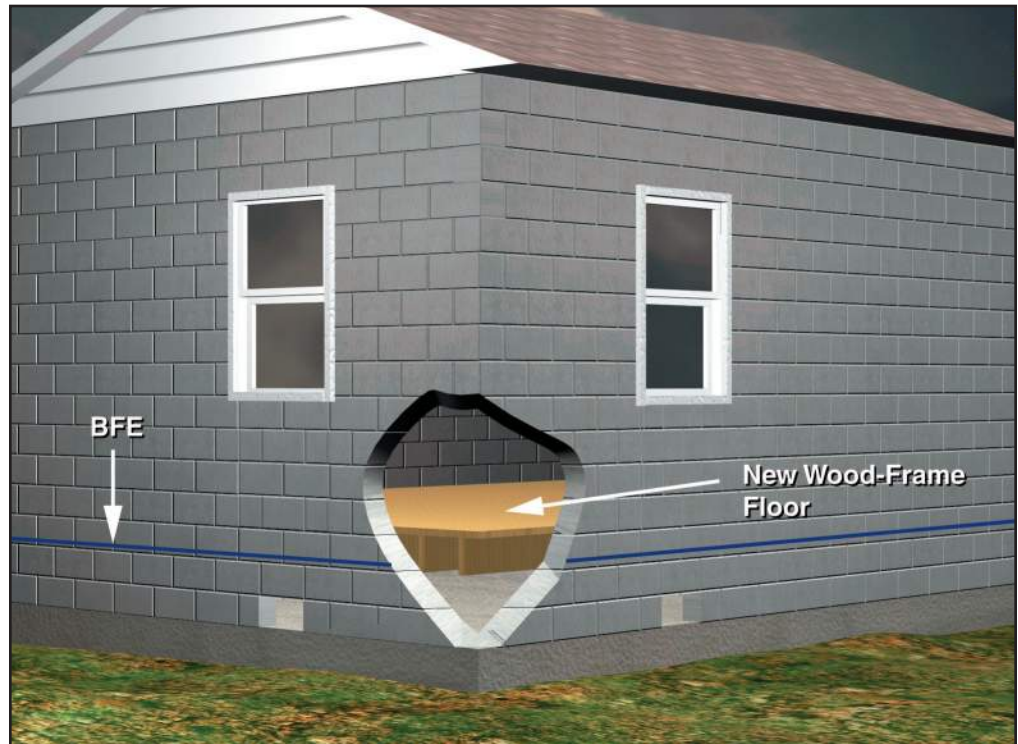
Figure 13
A new wood-frame lowest floor is constructed above the flood level, and the roof, windows, and doors are reinstalled.

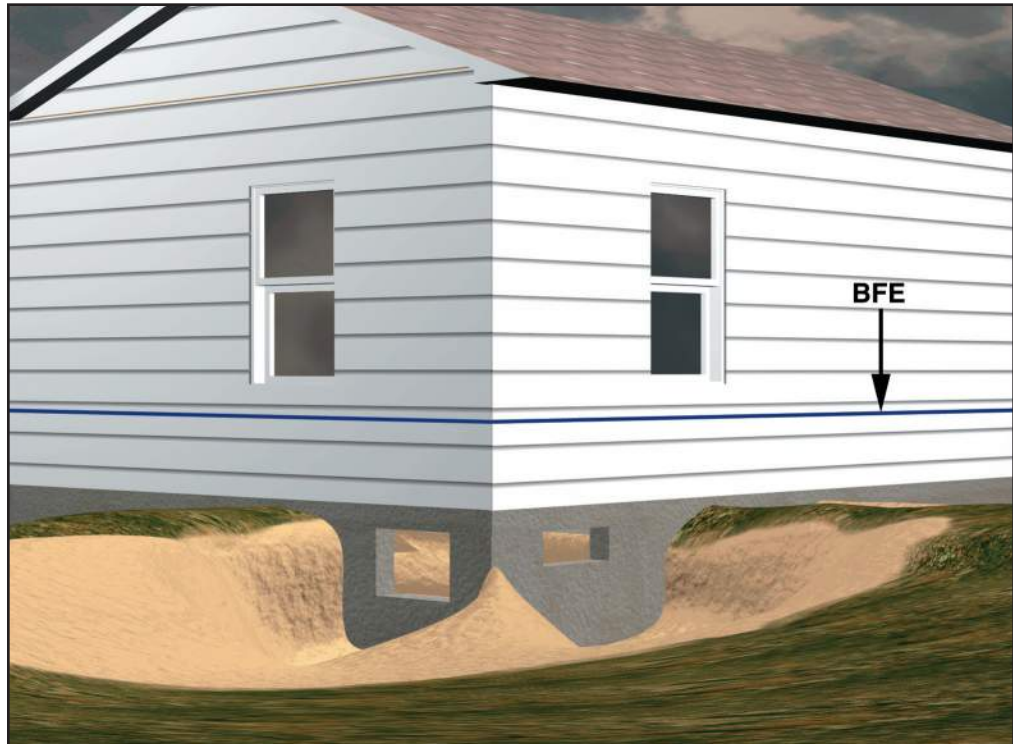
Figure 17
Trenches and tunnels under the slab provide access for the jacks and I-beams that will lift the house.

First, trenches are dug to expose the foundation walls immediately below the slab. Holes are then cut in the foundation walls at intervals around the house, and tunnels are dug under the slab (Figure 17). Jacks are placed in the trenches and large I-beams are inserted through the tunnels and allowed to rest on the jacks. Smaller I-beams are then inserted through the tunnels at right angles to the larger beams and positioned on top of them. The smaller beams support the slab when the house is raised (Figure 18).

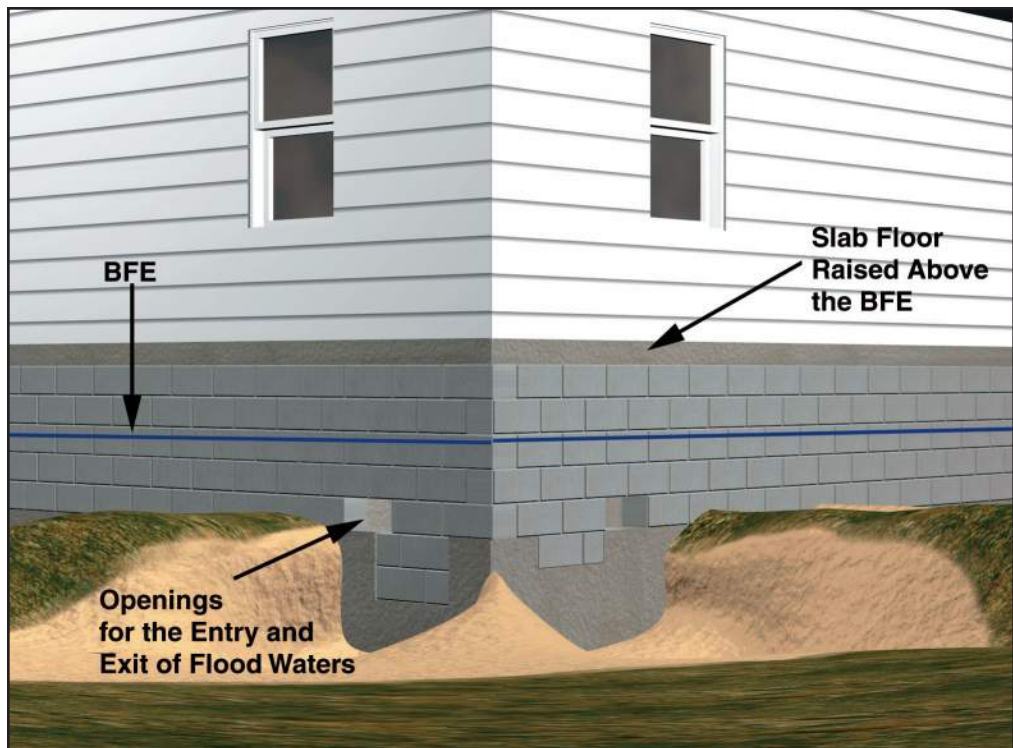
Figure 21
Elevated house and
slab on new, extended
foundation walls.

This process is repeated until the house is raised to the desired height. The foundation walls are then extended upward with additional rows of concrete block (Figure 20). As in the previous techniques, openings are made in the walls within 1 foot of the ground so that flood waters will be able to flow into and out of the area below the elevated floor. The jacks and beams are removed, and the openings left around the beams are filled with blocks (Figure 21).

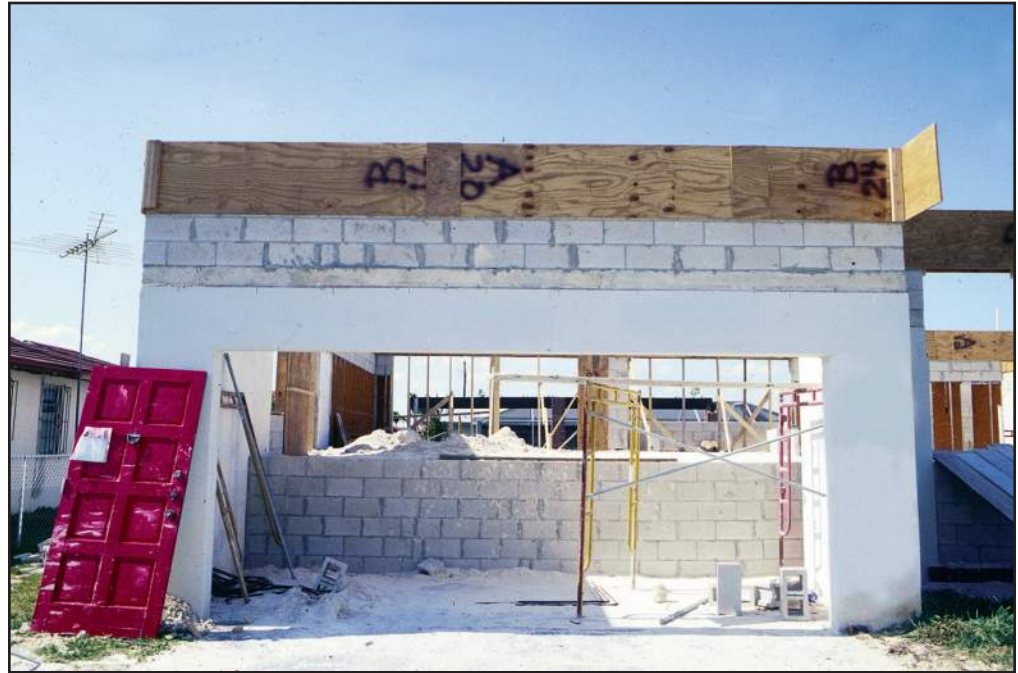
Figure 25

This view through the garage door reveals the different levels of the elevated slab floor, in the background, and the unelevated garage floor.

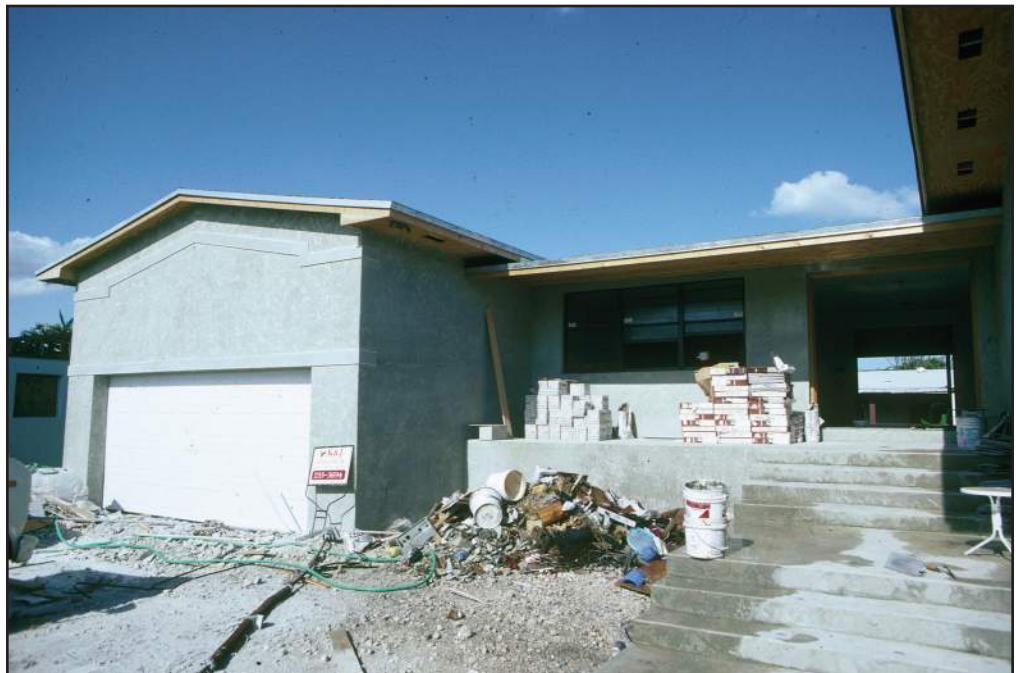
**Figure 37**

The project nears completion. In this house, as in Case Study 1, the level of the garage floor remains unchanged.

Figure 37 The project nears completion. 4-9

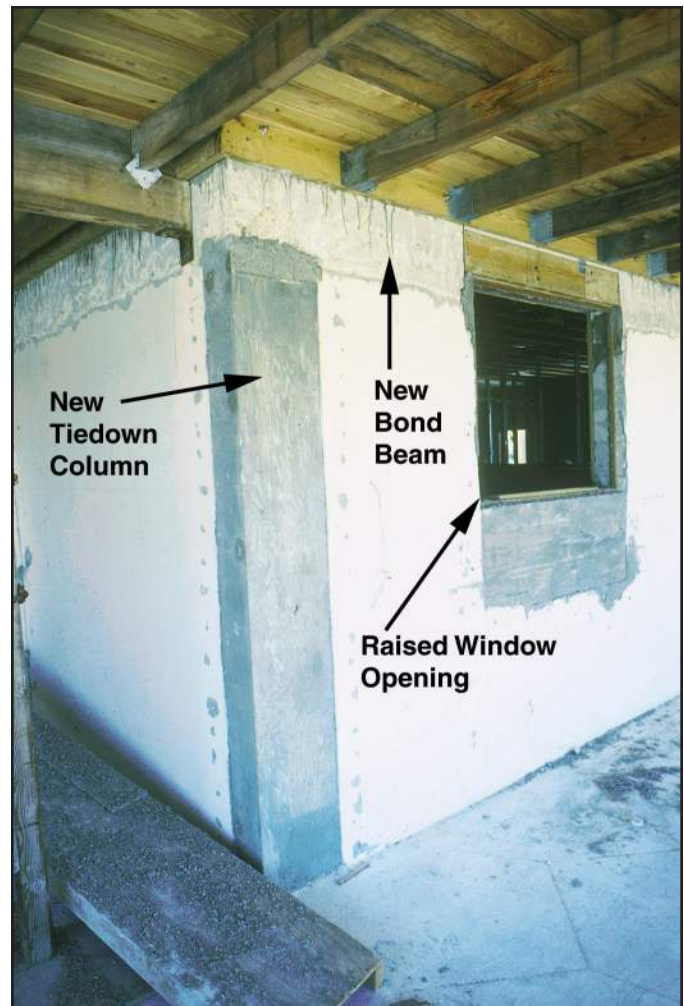
**Figure 41**

Note the new bond beam at the top of the extended wall, the new concrete tiedown column at the corner, and the raised window opening.

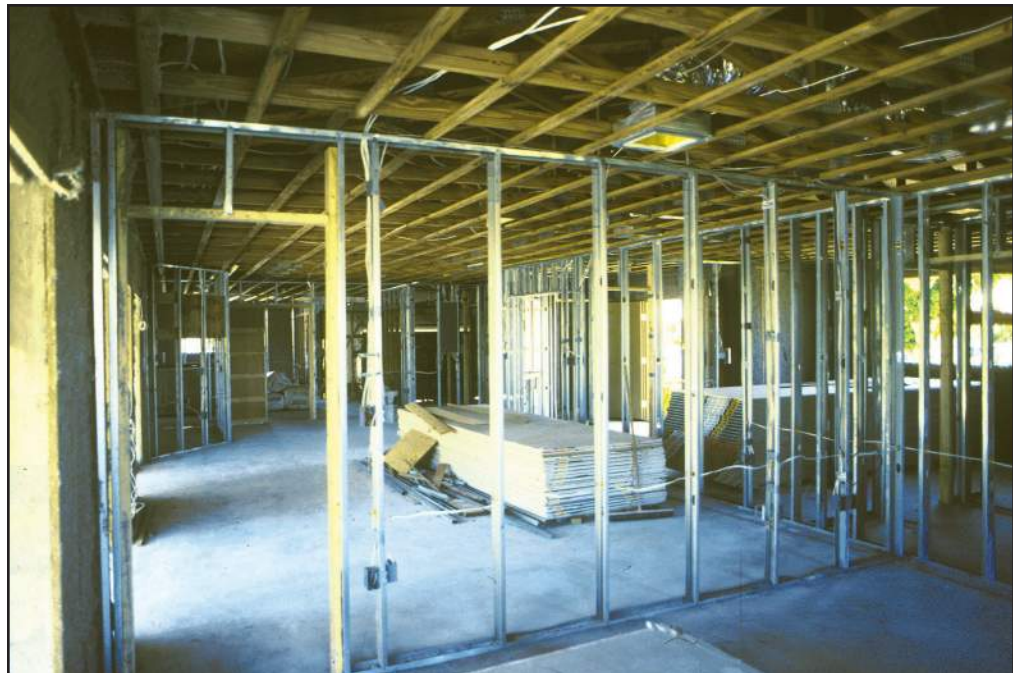
Figure 43

The owner of this house decided to use light-gauge metal framing for the new interior walls.

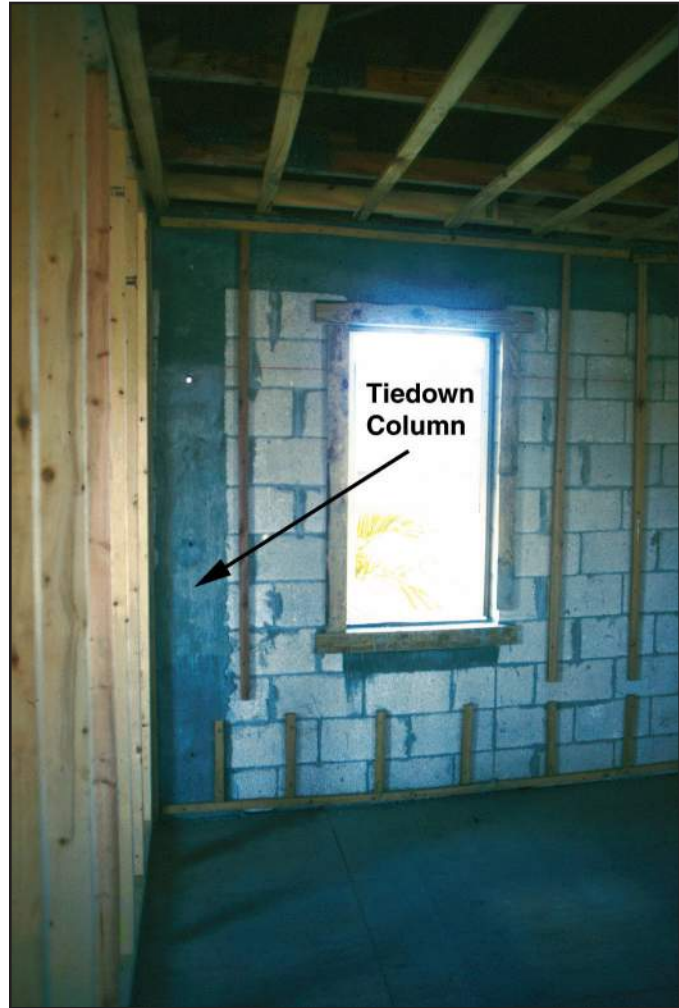
Figure 46
Concrete tiedown columns, such as the one to the left of the window in this photograph, were also used in this house.

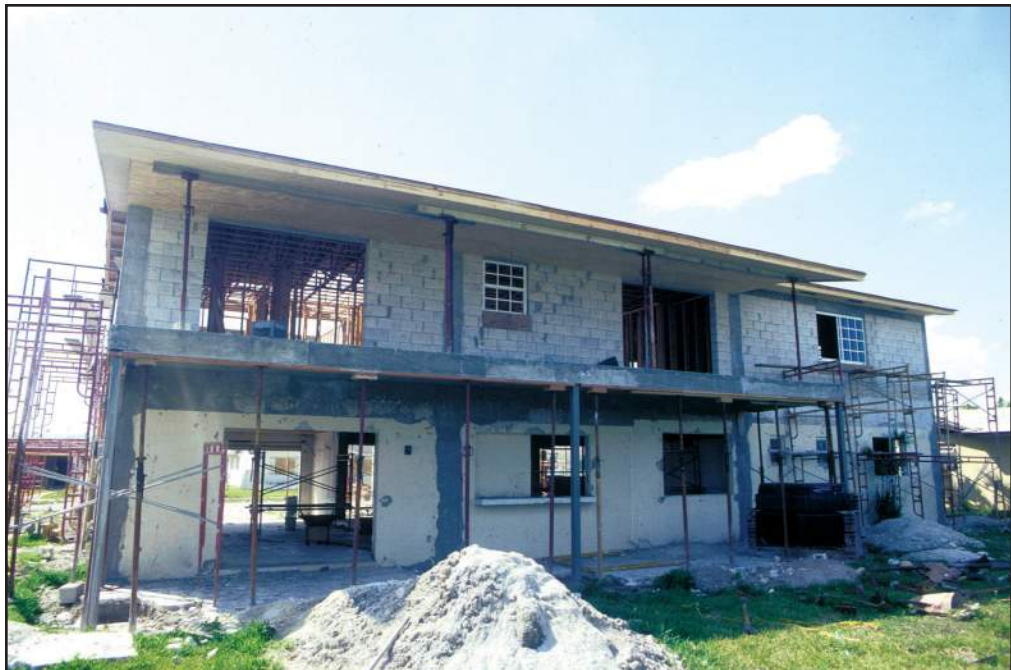
Figure 47
The tiedown columns extend down from the new second-story walls and into the original first-floor walls. The columns tie the first and second stories together and provide a continuous load path that helps the house resist the forces of high winds.

Figure 47	The tiedown columns extend down from the new second-story walls and into the original first-floor walls.	4-14
Figure 48	Wood 2 by 4 studs were used to frame the interior walls of the second story.	4-15
Figure 49	The house nears completion.	4-15
Figure 50	Not only does the completed house meet the requirements of local codes and the NFIP regulations, it now includes a substantial amount of parking and storage space below the new living level.	4-16
Figure 51	The storm-damaged first story has been gutted in preparation for construction.	4-16
Figure 52	The existing first-story walls have been strengthened by the addition of concrete block.	4-17
Figure 53	As the second story takes shape, its size in relation to the size of the original house becomes apparent.	4-17

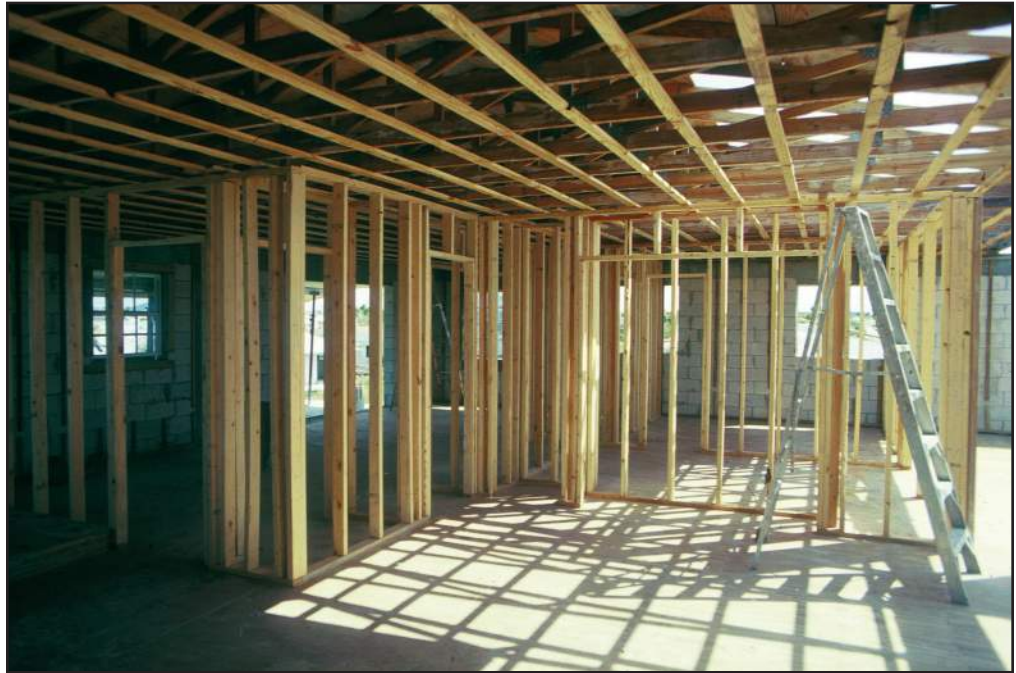
Figure 48
Wood 2 by 4 studs
were used to frame
the interior walls of
the second story.

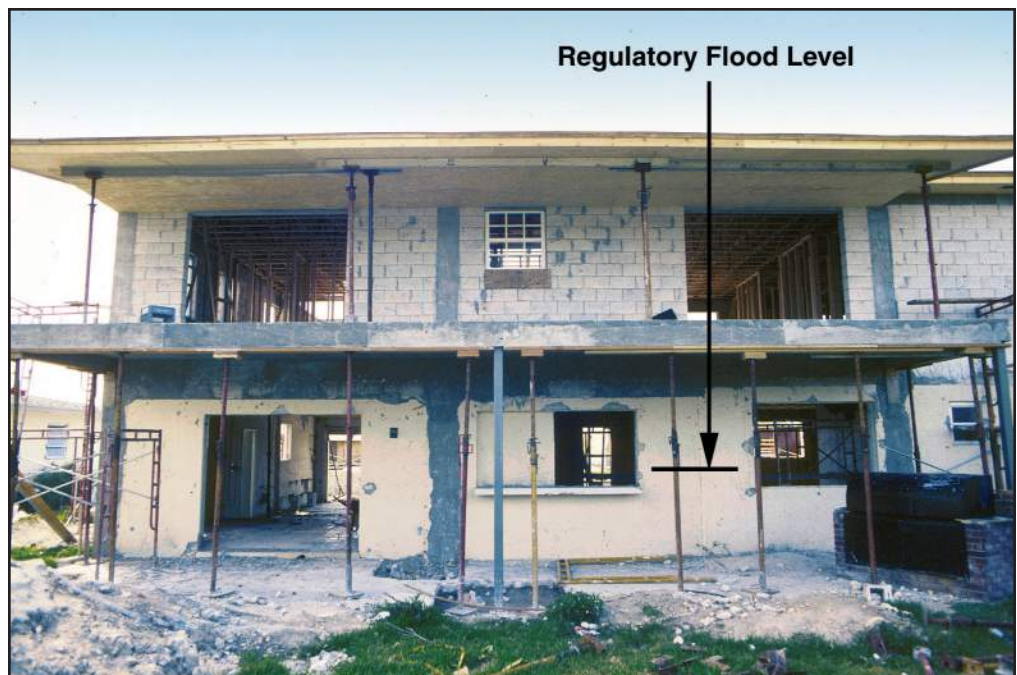
Figure 49
The house nears
completion.

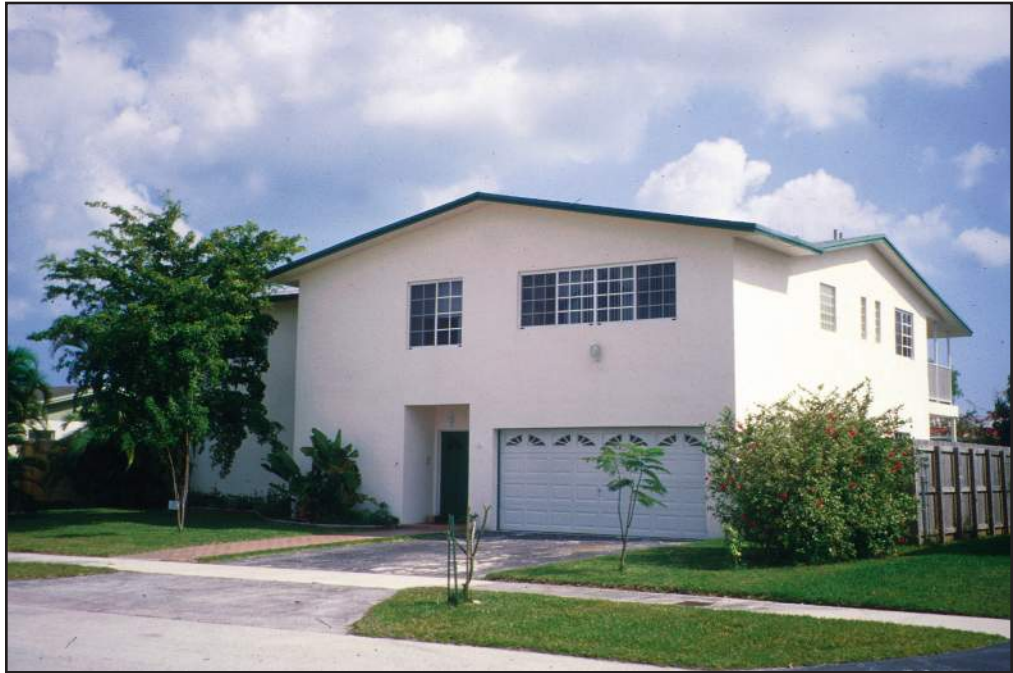
Figure 50

Not only does the completed house meet the requirements of local codes and the NFIP regulations, it now includes a substantial amount of parking and storage space below the new living level. In addition, because the lowest floor is now over 4 feet above the regulatory flood elevation, the house is eligible for NFIP flood insurance at a greatly reduced rate of coverage.

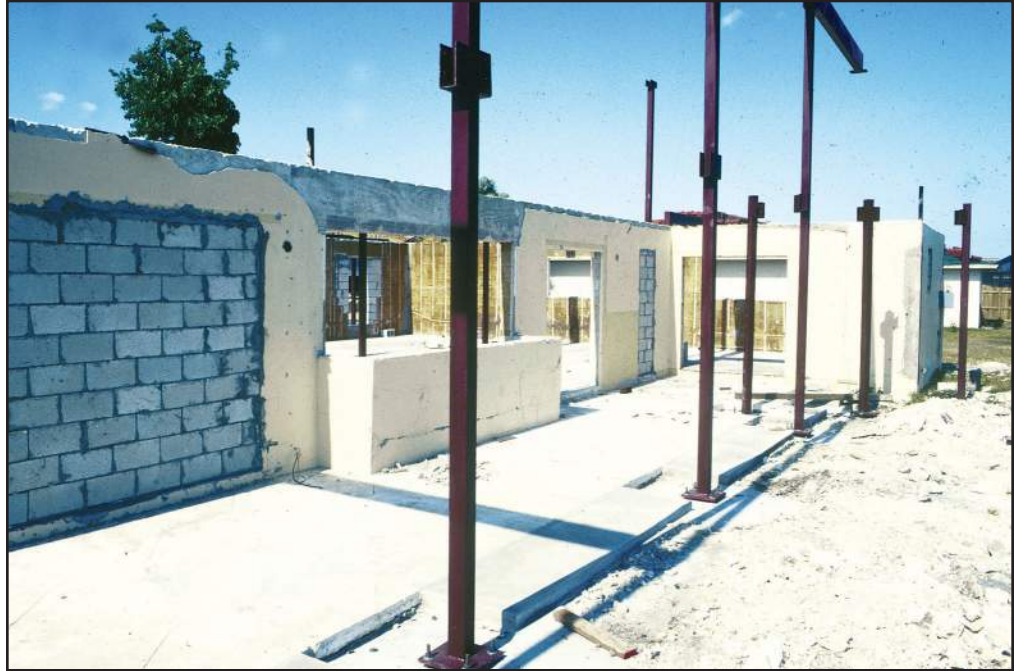
Figure 52

The existing first-story walls have been strengthened by the addition of concrete block. Metal columns and beams have been added to help support the new second story.

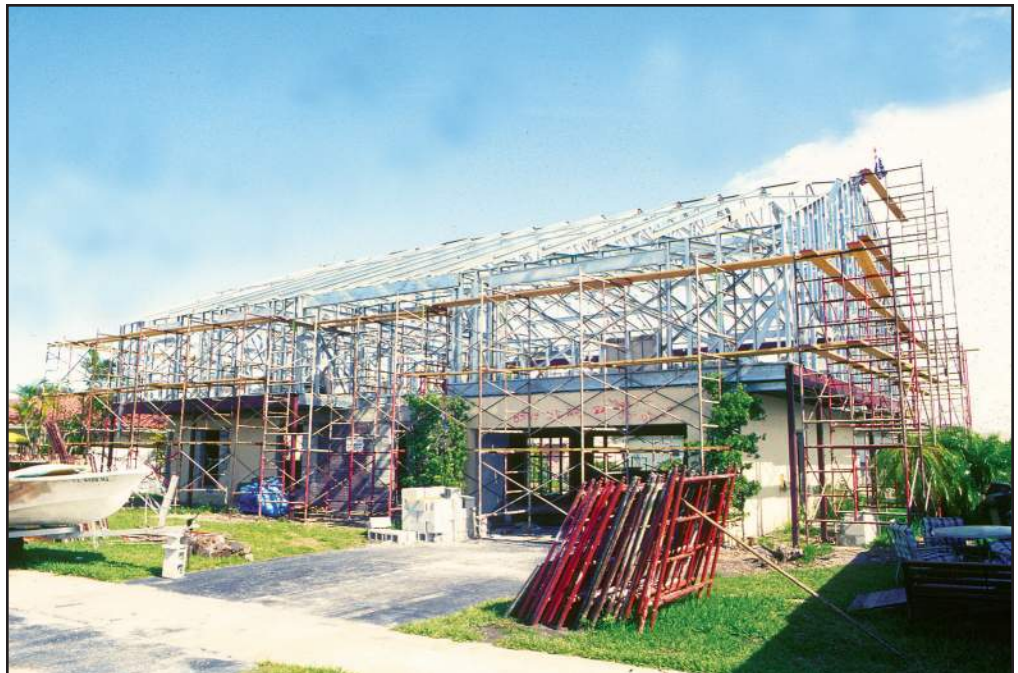
**Figure 53**

As the second story takes shape, its size in relation to the size of the original house becomes apparent.

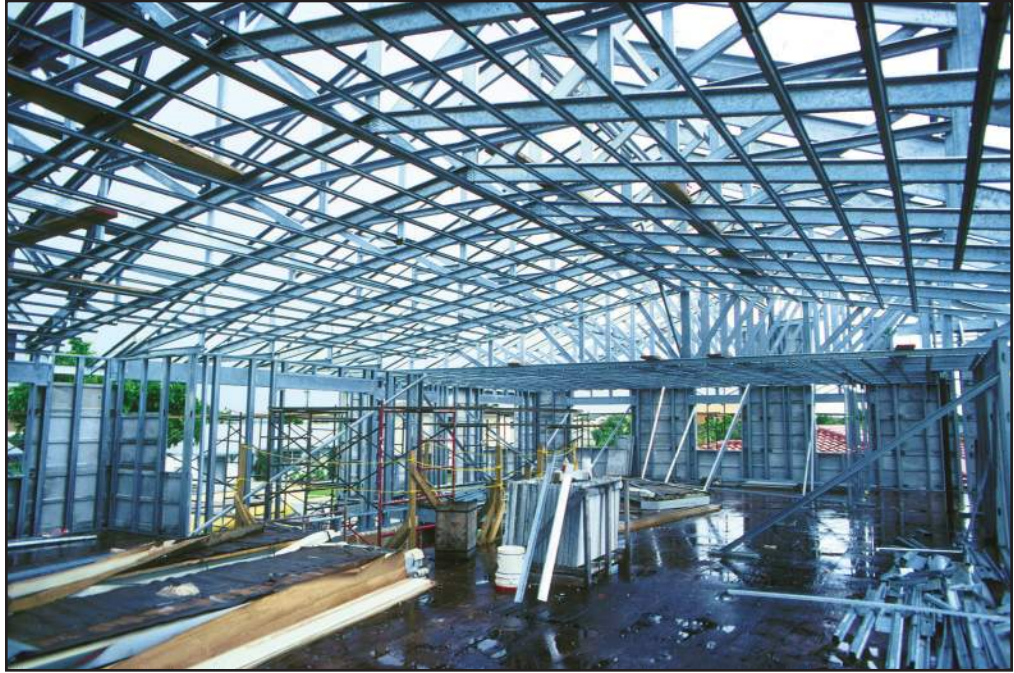
Figure 54
Metal framing is used for the new second story, including the walls and roof support system.

Figure 54 Metal framing is used for the new second story, including the walls and roof support system. 4-18

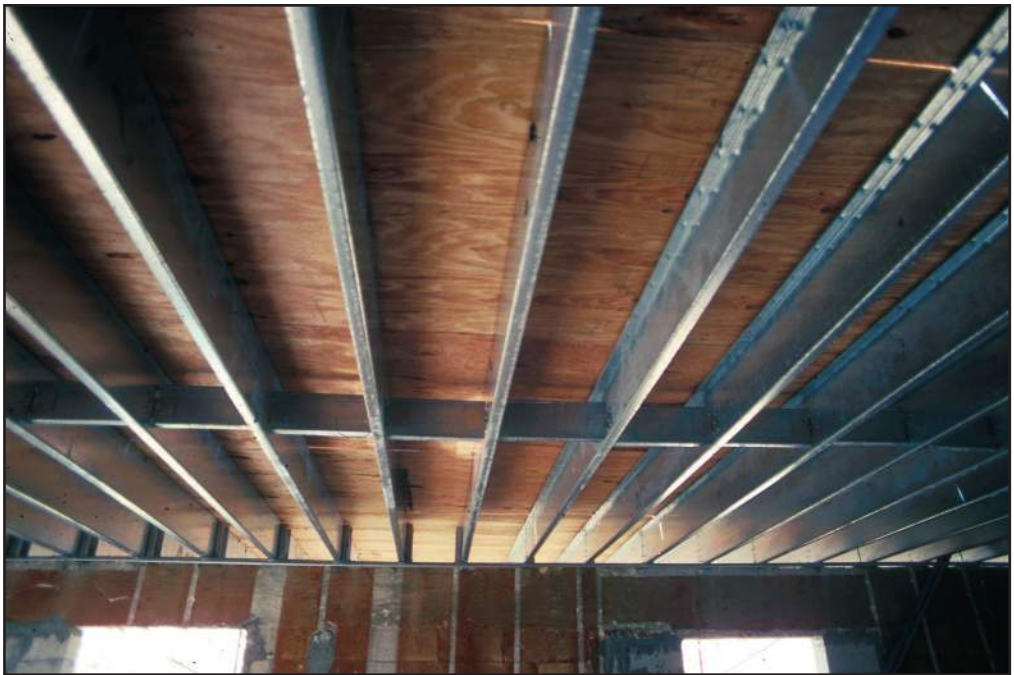
Figure 55
Metal framing also supports the floor of the new second story.

Figure 55 Metal framing also supports the floor of the new second story. 4-18

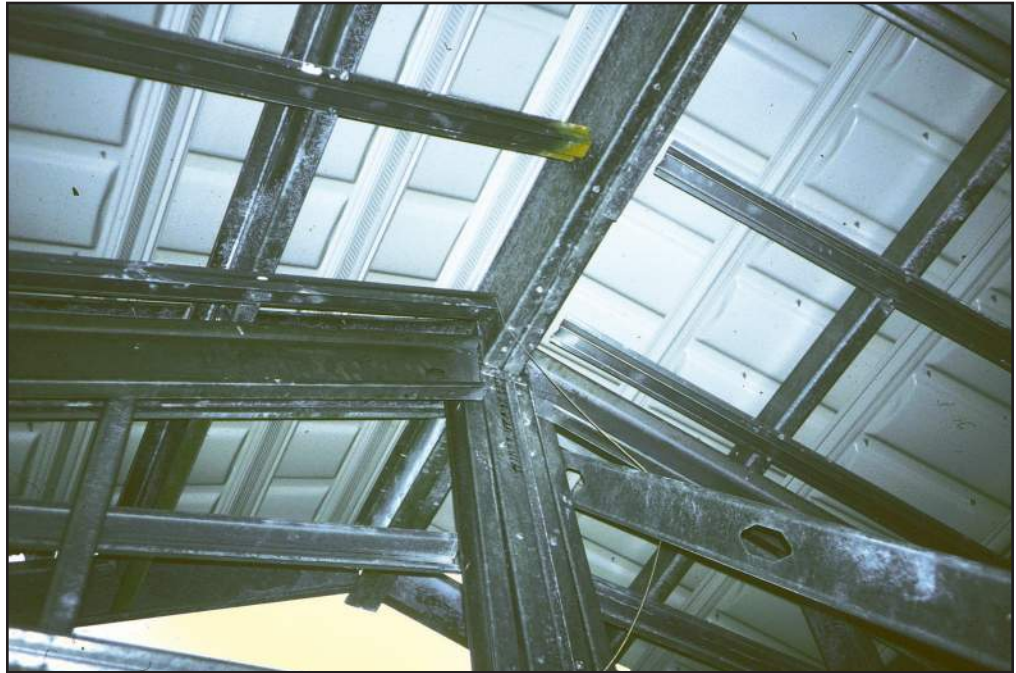
One advantage of metal framing is its relatively light weight. An additional advantage is that the screws used to attach metal-frame components provide strong connections.

Figure 56 One advantage of metal framing is its relatively light weight. 4-19

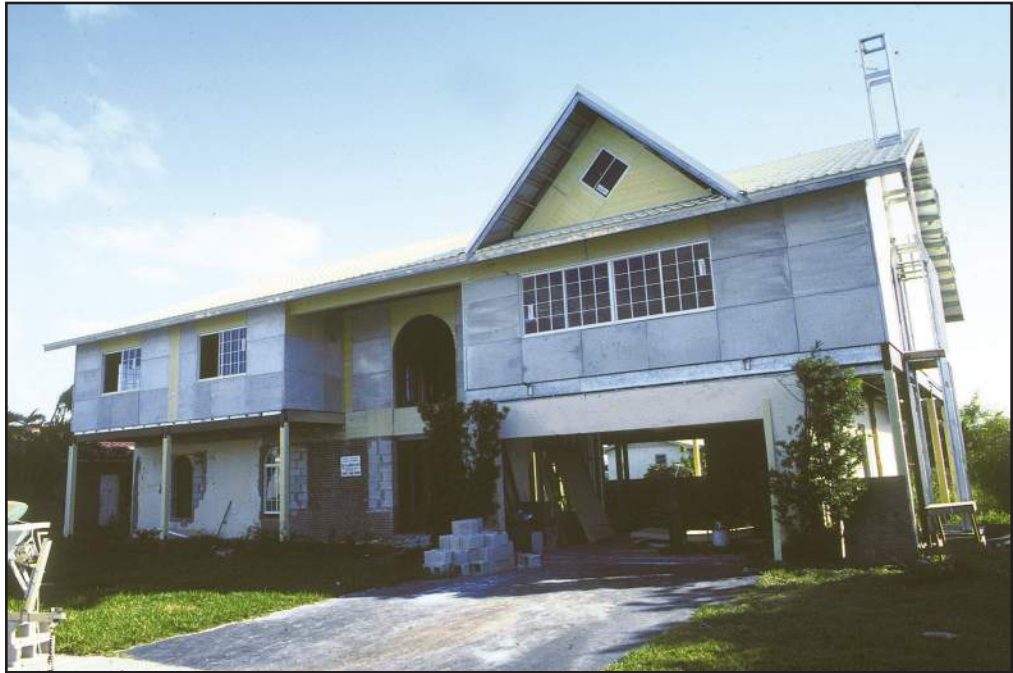
The new second story
nears completion.
The roof is made of
formed metal panels.

Figure 58 The new second story nears completion. 4-20

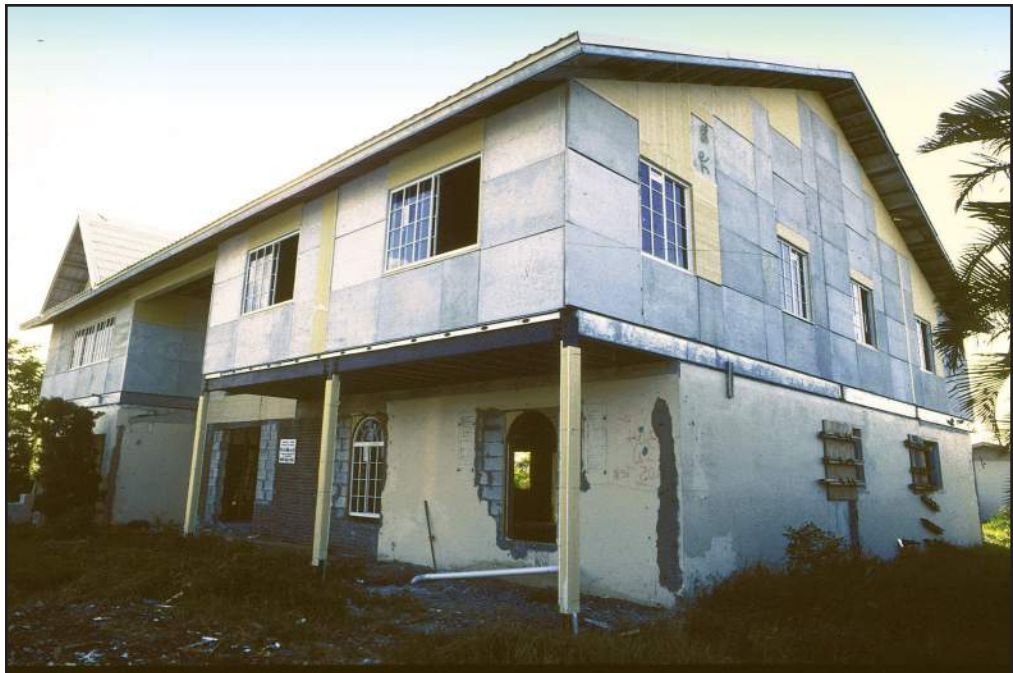
The exterior
walls consist of
prefabricated
concrete panels.
Innovative techniques
such as those
employed in this
project are helping
homeowners who
need practical and
economical methods
of repairing and
protecting their
houses.

Figure 59 The exterior walls consist of prefabricated concrete panels. 4-20

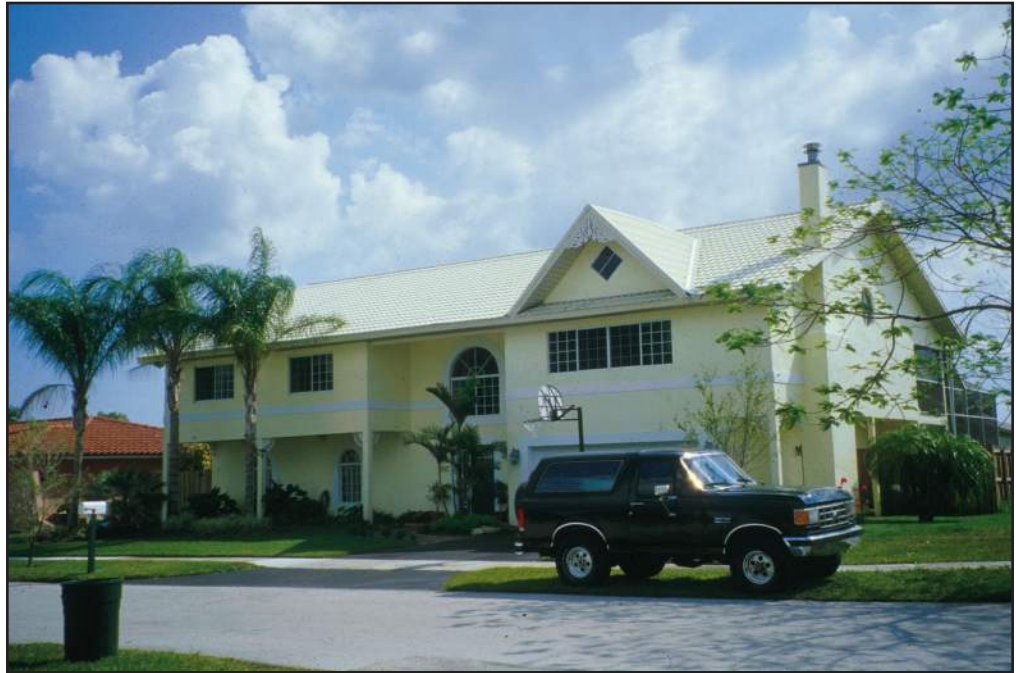
The completed house has the appearance of a typical two-story residence. As in the house in Case Study 2, the lower floor is used only for parking, storage, and building access; the new second story provides the living space.

Figure 60 The completed house has the appearance of a typical two-story residence. 4-21

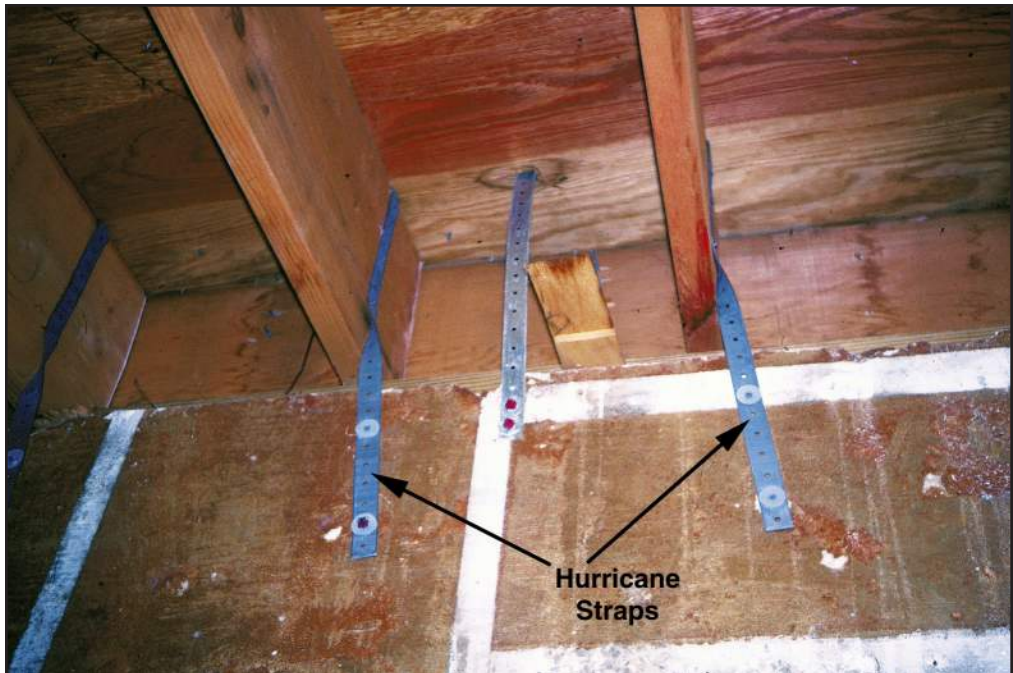
Figure 63
The new second-story walls are securely connected to the original first-floor walls with galvanized metal hurricane straps.

Figure 63 The new second-story walls are securely connected to the original first-floor walls with galvanized metal hurricane straps. 4-22

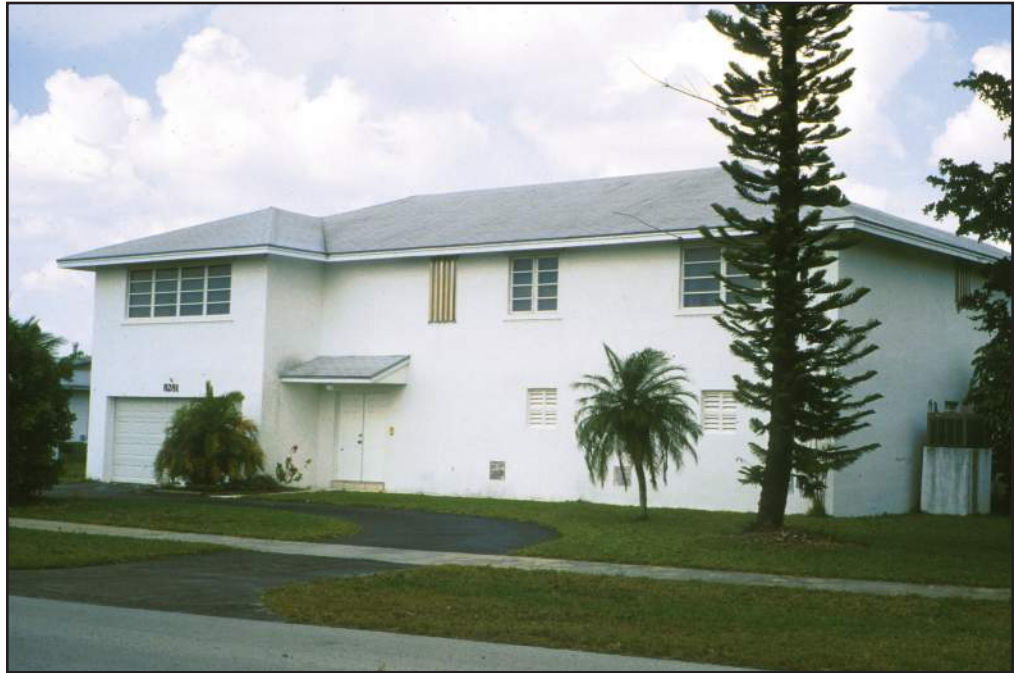
Figure 64
From the outside, the completed house, with its stucco walls, looks like a conventional masonry house.

Figure 64 From the outside, the completed house, with its stucco walls, looks like a conventional masonry house. 4-23

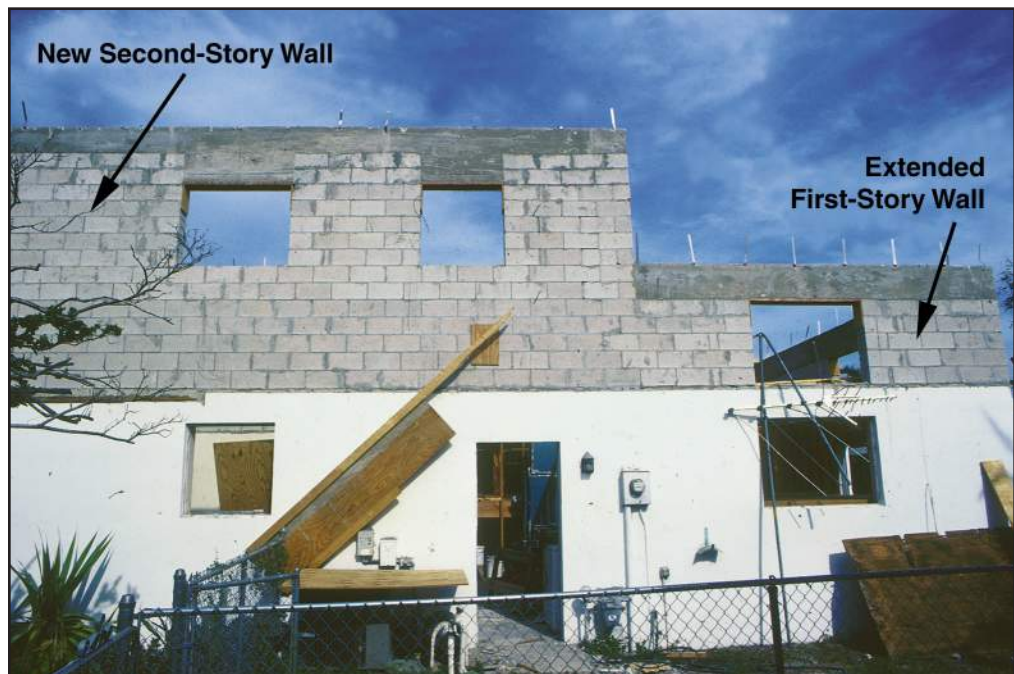
After the house was gutted, the walls were extended upward with reinforced concrete block. In this view from behind the house, the rear wall of the new second story can be seen on the left and the extended first-story wall on the right. Note the new raised window opening in the extended wall, just above the original opening.

Figure 65 After the house was gutted, the walls were extended upward with reinforced concrete block. 4-24

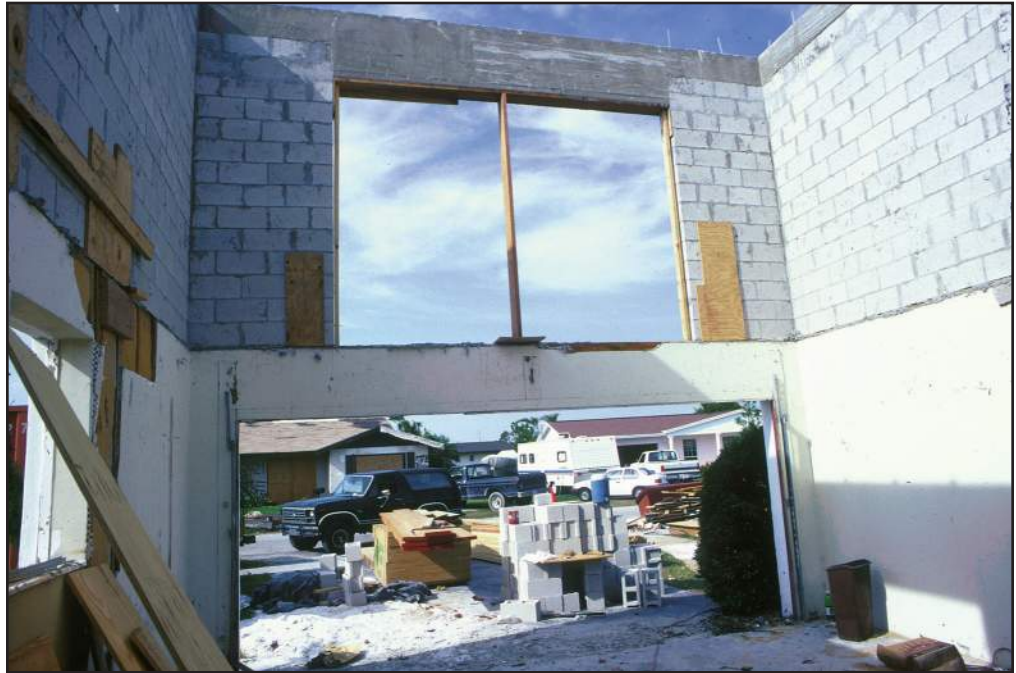
Figure 66
The new second-story walls as seen from inside the garage.

Figure 66 The new second-story walls as seen from inside the garage. 4-25

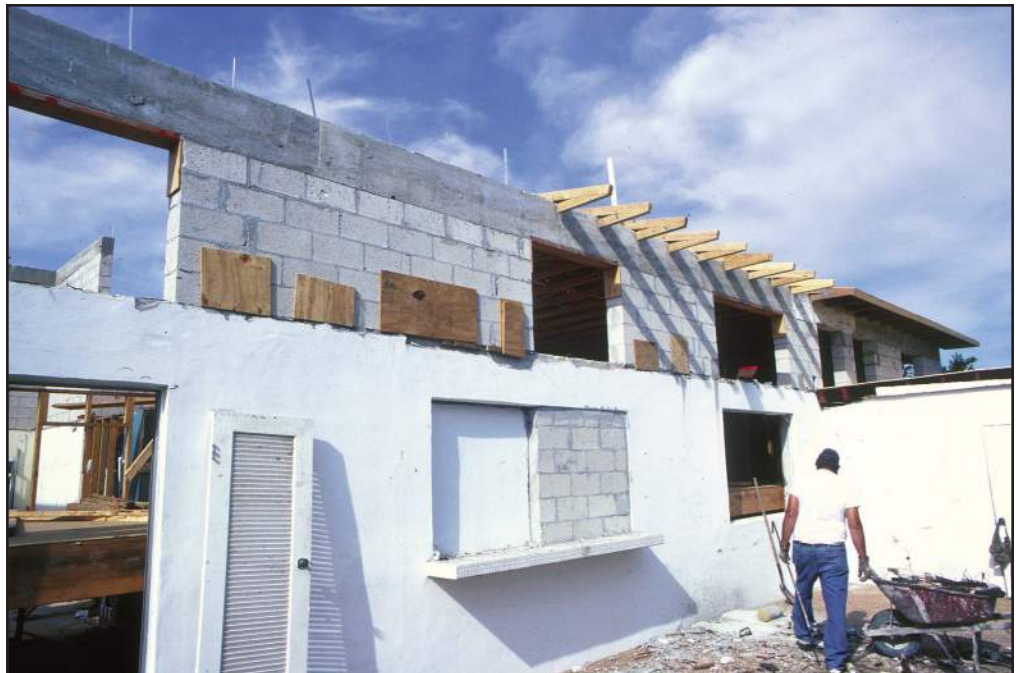
Figure 67
The extended first-story walls.

Figure 67 The extended first-story walls. 4-25
