Above the Flood: Elevating Your Floodprone House

FEMA 347/ May 2000

Hurricane Andrew damaged hundreds of homes in south Florida.

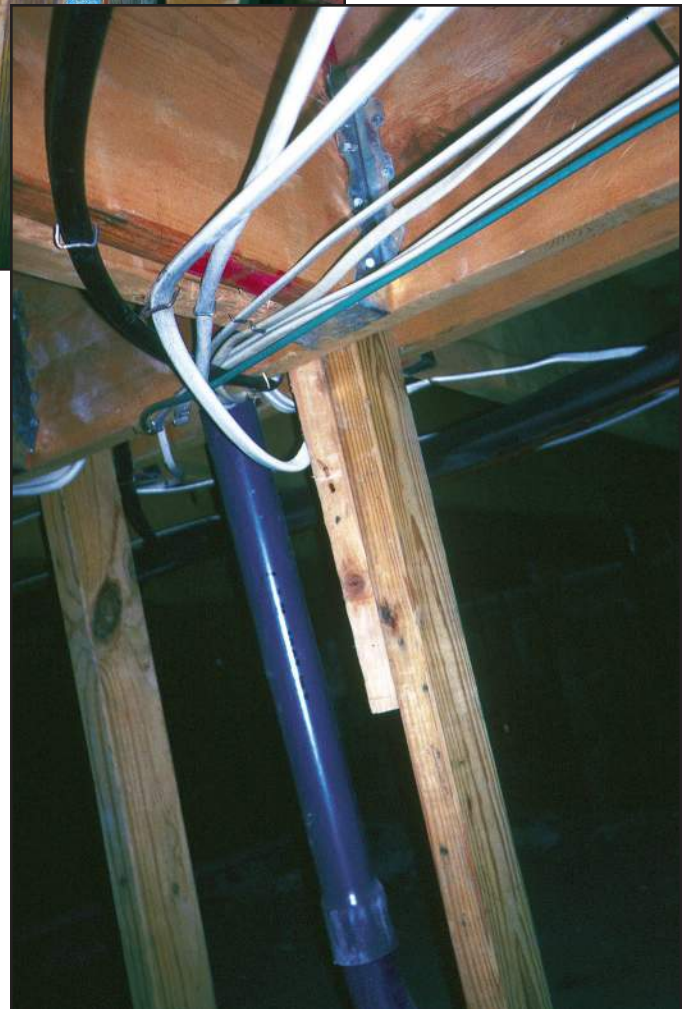
**Figure 71**

All plumbing and electrical renovation work must be performed according to state and local code requirements.

Figure 71 All plumbing and electrical renovation work must be performed according to state and local code requirements. 4-27

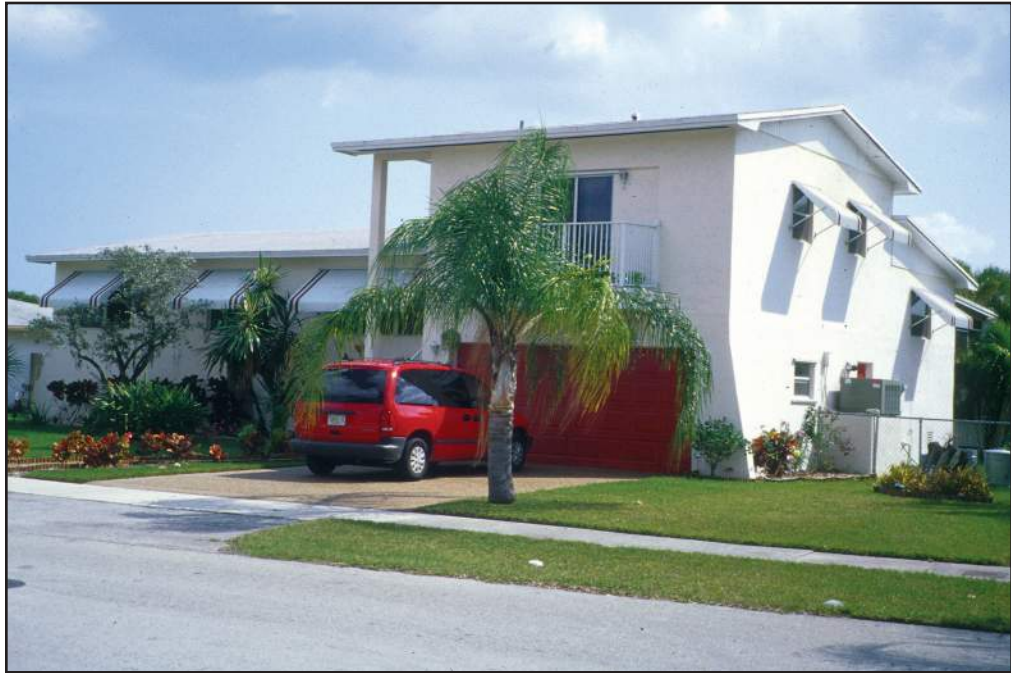
Figure 72
The completed house is compliant with local floodplain management requirements, is more resistant to flood damage, and provides additional living area above the flood level.

Figure 72 The completed house is compliant with local floodplain management requirements, is more resistant to flood damage, and provides additional living area above the flood level. 4-28

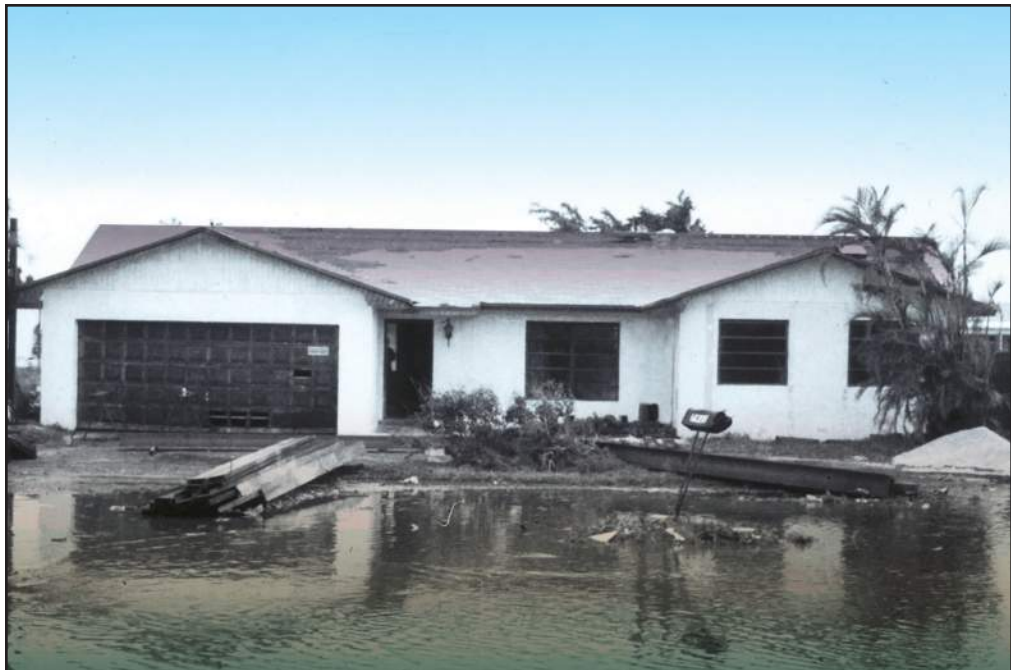
Figure 73
Like the houses shown previously, this one-story house, with its concrete block walls, concrete slab foundation, and attached garage, is typical of the houses in the area affected by Hurricane Andrew.

Figure 73 Like the houses shown previously, this one-story house, with its concrete block walls, concrete slab foundation, and attached garage, is typical of the houses in the area affected by Hurricane Andrew. 4-28

Unlike Techniques 1 and 2, which build up from the existing foundation and walls, Technique 3 lifts the entire house with hydraulic jacks and builds a new foundation below it (Figures 73–85).

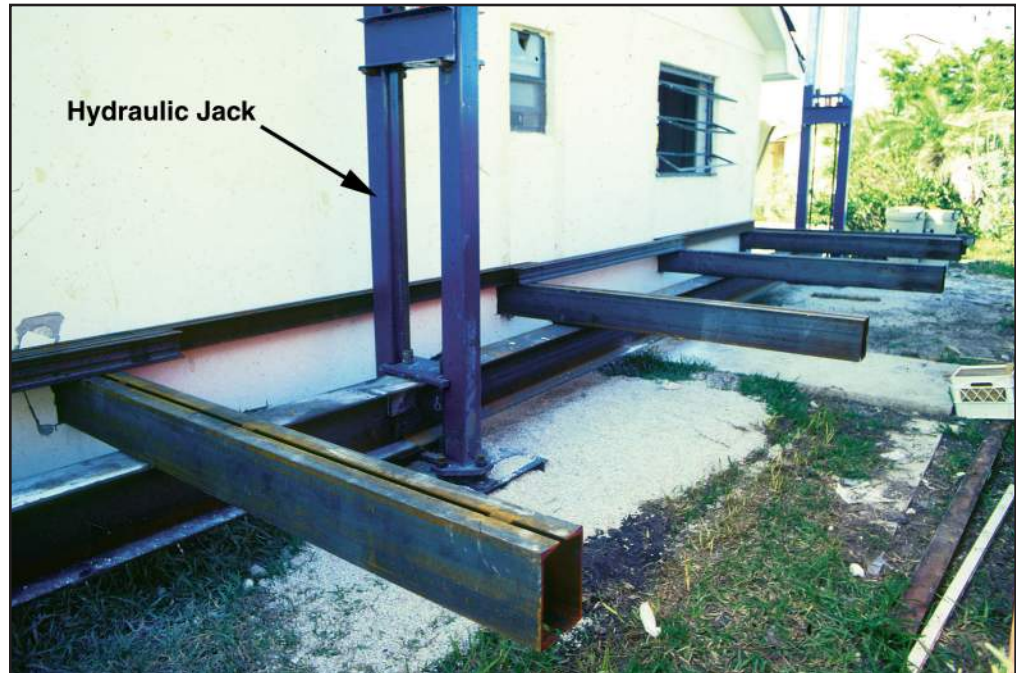
In this variation of Technique 3, steel beams are inserted through the walls of the house rather than under the slab. The beams span the length and width of the house and cross one another inside to create a grid. Outside the house, the beams rest on larger beams that will be raised with hydraulic jacks.

Figure 74 In this variation of Technique 3, steel beams are inserted through the walls of the house rather than under the slab. 4-29

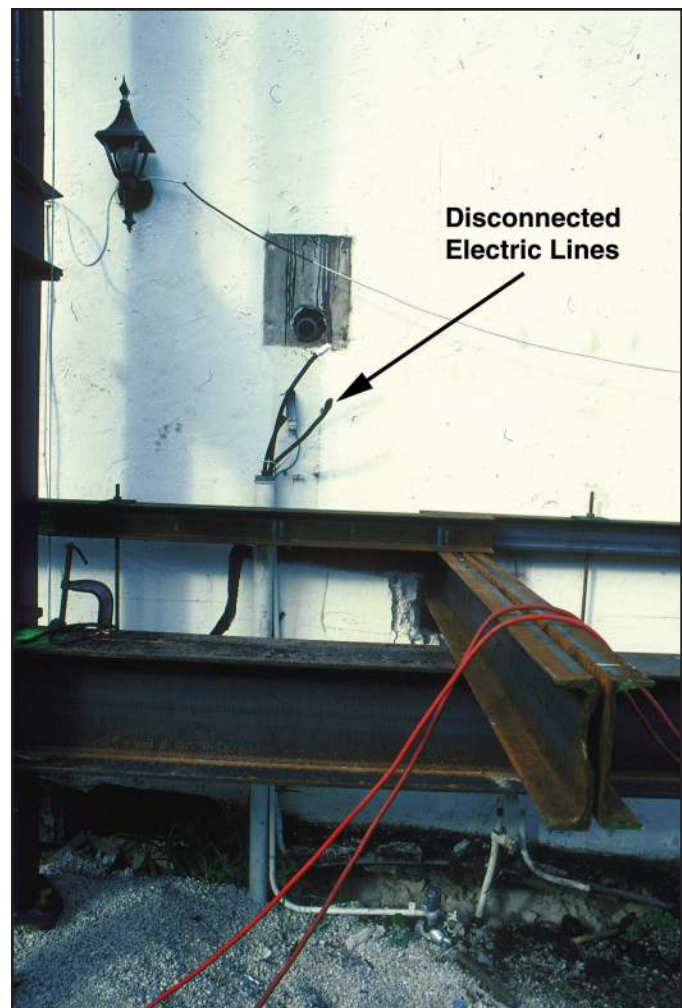
**Figure 75**

Electrical lines and other utilities were disconnected early in the project.

Figure 75 Electrical lines and other utilities were disconnected early in the project. 4-29

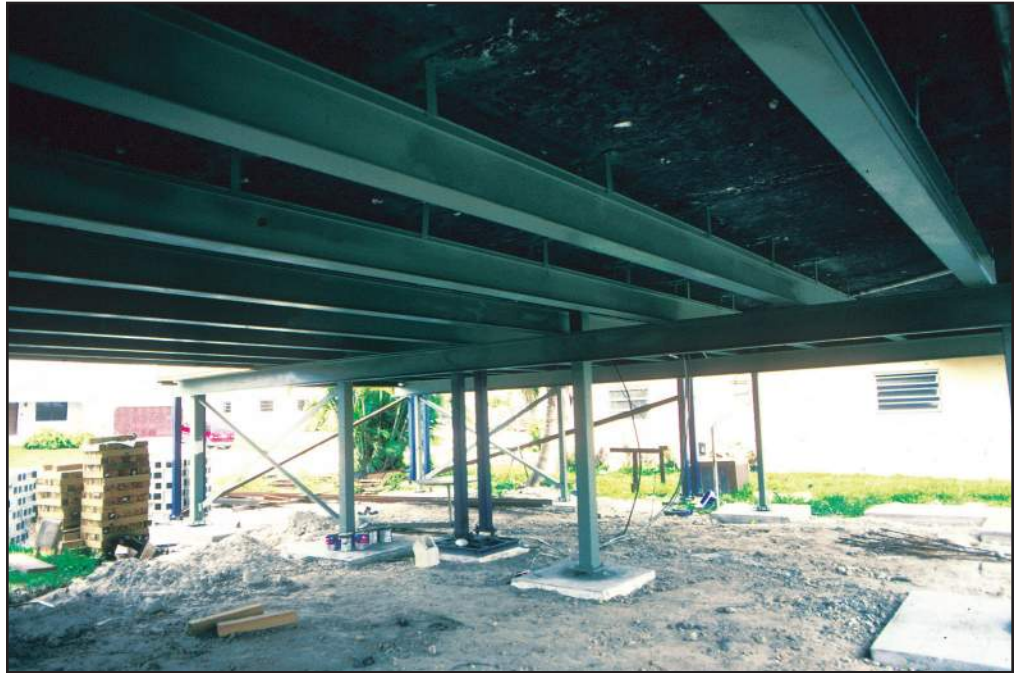
Figure 82
While the jacks and beams supported the house, new steel foundation members were installed below.

Figure 82 While the jacks and beams supported the house, new steel foundation members were installed below. 4-33

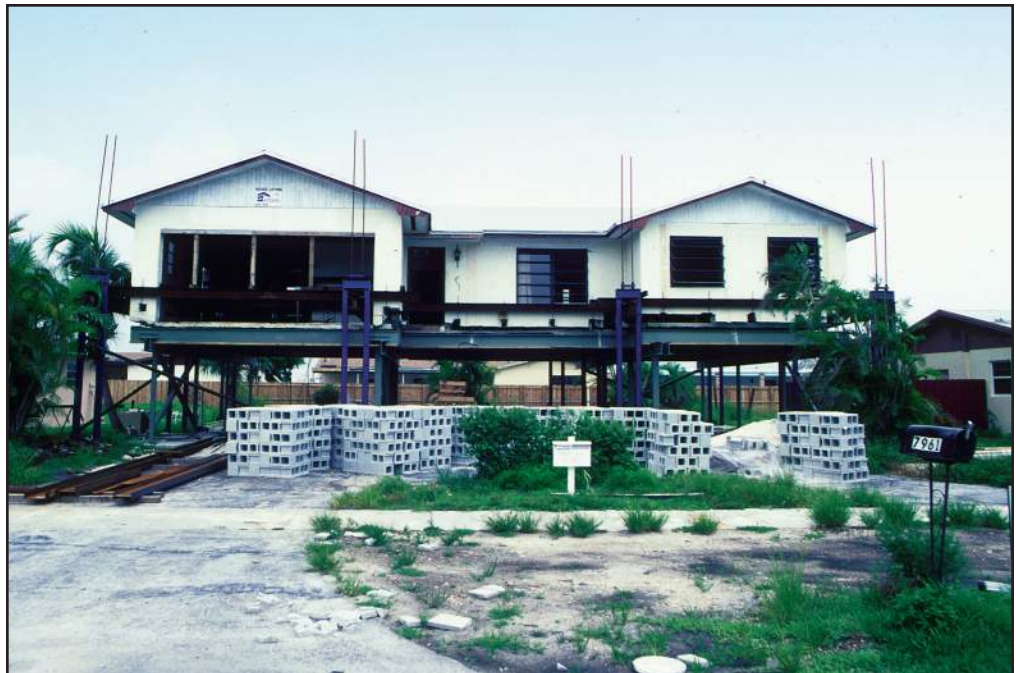
Figure 83
Concrete blocks were brought to the site ...

Figure 83 Concrete blocks were brought to the site 4-33
